ETL in Serenity with new Setup Test

Author: Naomi Gonzalez

Date: 22 and 23 July 2025

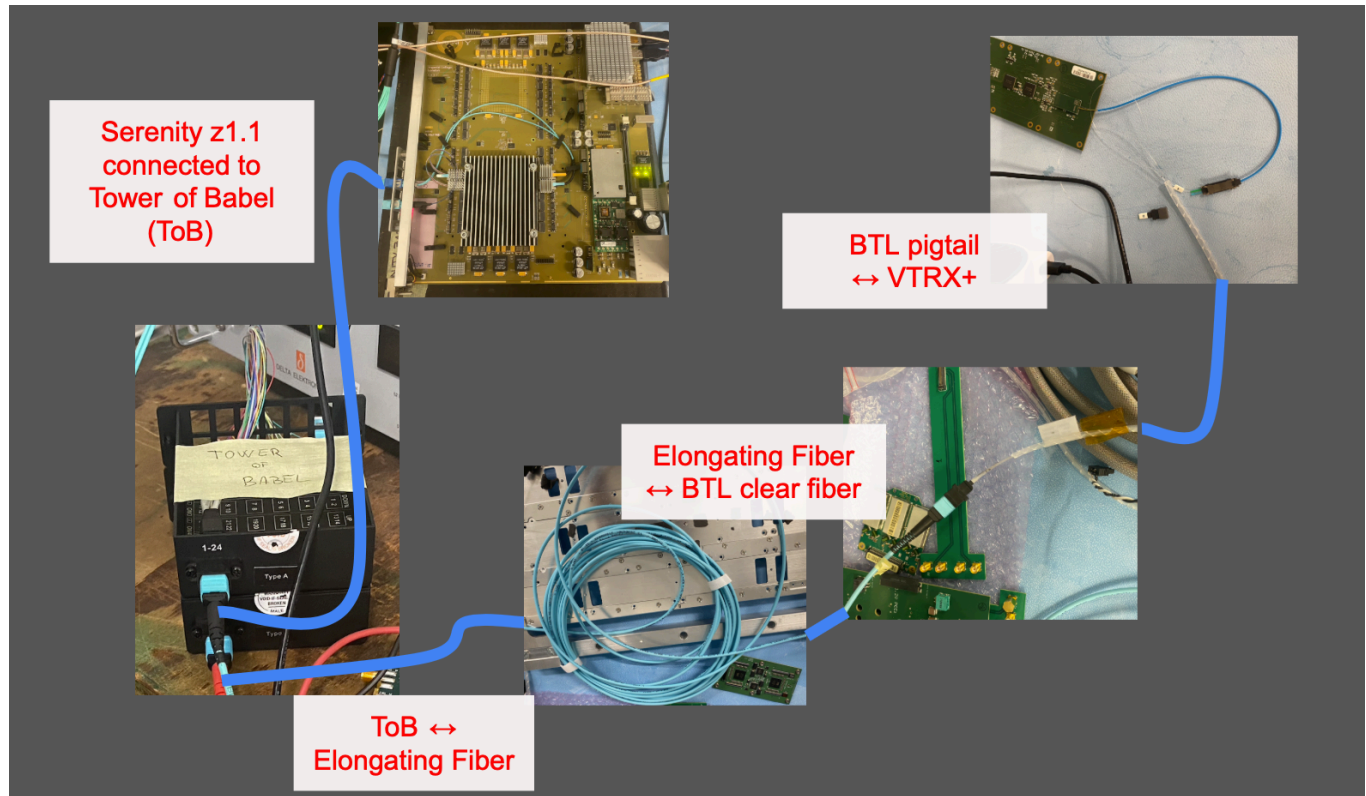
In all previous Serenity test this was our testing set-up which was created by BTL people:

After doing more research on the hardware we realized 2 main problems

1. BTL clear fiber only allows for one uplink per VTRX Connector which is incompatible with our setup since the VTRX tries to send 2 uplinks
2. The elongated fiber was not clean

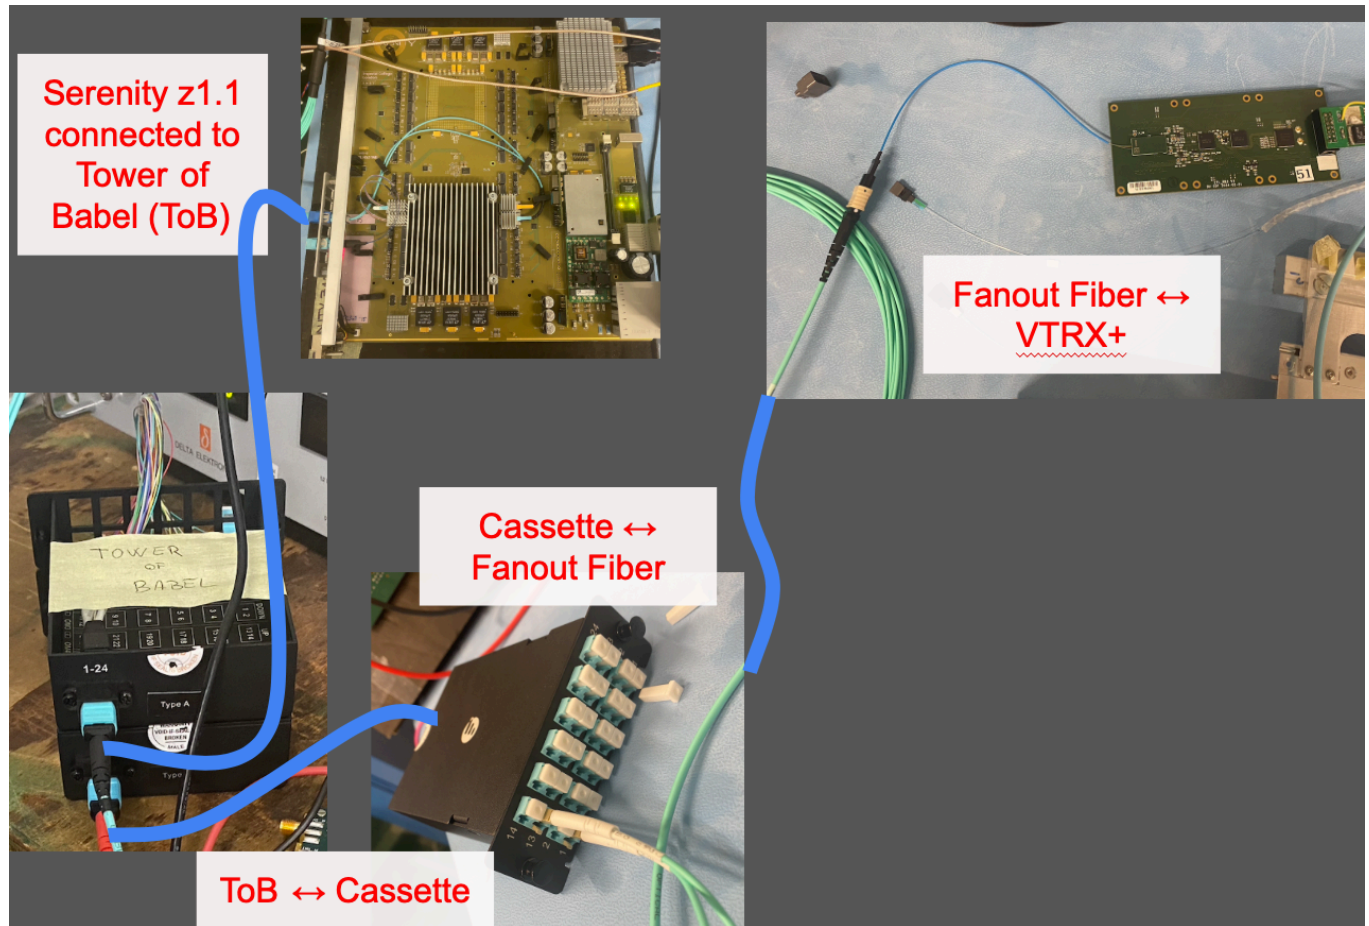
This is the new setup we used for these tests to address those issues:

We can confirm that we can now read and write to the master IpGBT. The new setup solved the previous issue of never receiving any data from the uplink. We no longer see timeout errors when the fanout fiber number 7 is connected to slot 1 and fiber number 6 is connected to slot 13 on the cassette.

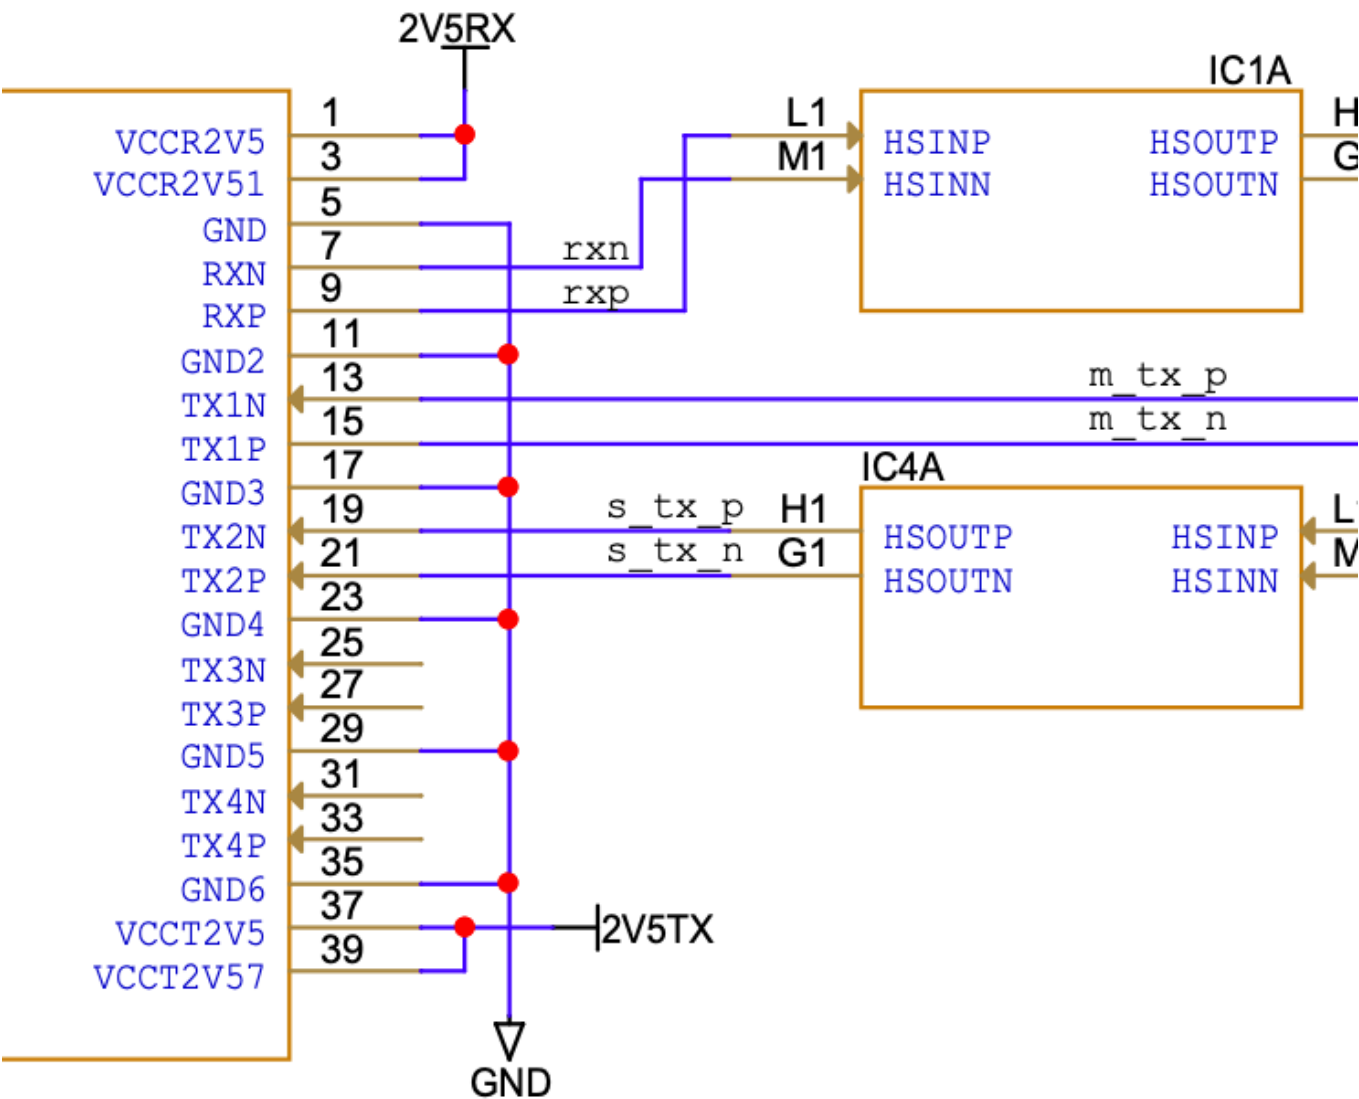
Here is how the VTRX is connected to the RB based on the schematic:

Based on the previous 2 images we can concur that to connect only the master IpGBT uplink we would need to plug in fiber number 6 (TX1). And the downlink is fiber number 7.
